Manhole Inspection Summary

Manhole # S09GG2010MH

Location Address: **6000 GREEN MEADOW PKWY** Cross Street: **WESTERN PARK DR**

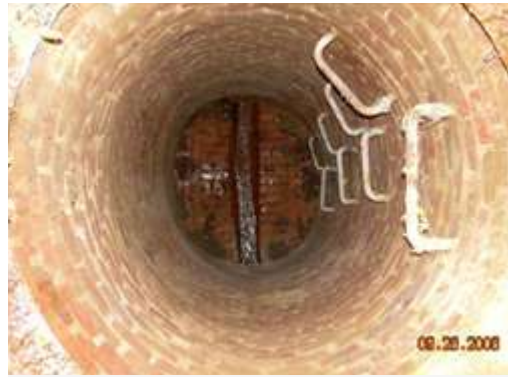
Top View

Corroded steps. Evidence of surcharge - Bench debris.

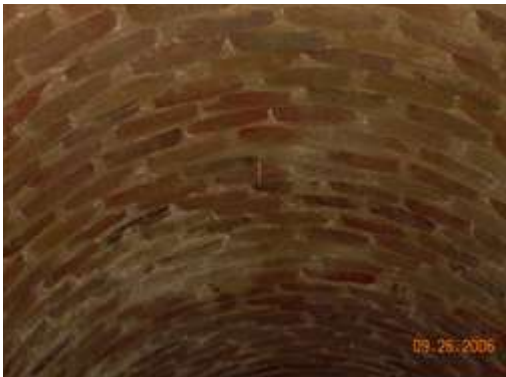
Defect

Barrel Material: **Brick** ☐ Parged
Shape: **Circular** Diameter: **42** (in.) Length: (in.)
Condition: ☐ Sound ☐ Cracked ☒ **Root Intrusion** ☐ Loose Brick ☐ Deteriorated
Infiltration: ☐ None ☐ Joint ☐ Cracks ☒ **Mortar** ☒ **Roots** ☒ **Wall**

Barrel root intrusion and infiltration.

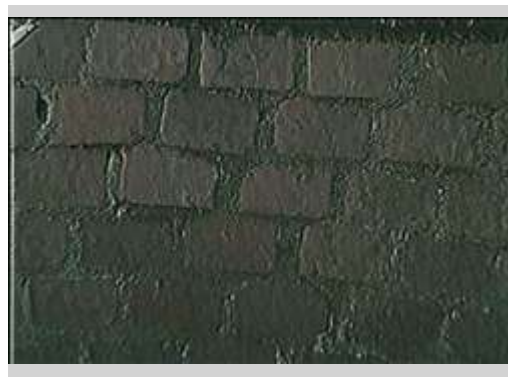
Defect

Chimney / Frame Adjustment ☒ Exists Material: **Brick** ☐ Parged Height: **3** (in.)
Condition: ☐ Sound ☐ Cracked ☐ Root Intrusion ☐ Loose Brick ☒ **Deteriorated**
Infiltration: ☐ None ☒ **Joint** ☐ Cracks ☒ **Mortar** ☐ Roots ☐ Wall

Adjustment deterioration and infiltration.

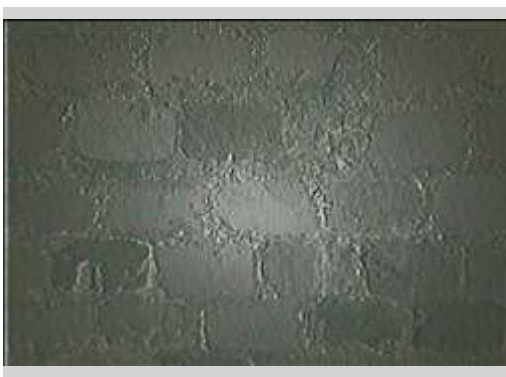
Defect

Corbel Material: **Brick** ☐ Parged Type: **Concentric/Eccentric**
Condition: ☒ Sound ☐ Cracked ☐ Root Intrusion ☐ Loose Brick ☐ Deteriorated
Infiltration: ☐ None ☐ Joint ☐ Cracks ☒ **Mortar** ☐ Roots ☒ **Wall**

Corbel infiltration.

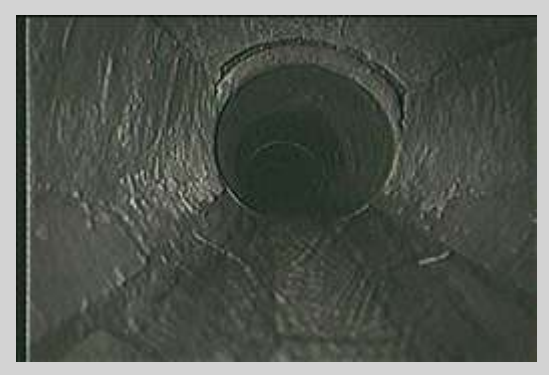
8 in. Circular Gravity Sewer Pipe In @ 6 O'Clock

Comments **The I6 pipe seal is not flush to the pipe.**

Infiltration: **Evidence** Pipe Seal Cond: **Unknown**
